# SUMMARY REPORT

# CONTINUATION OF THE INVESTIGATION OF THE REACTION OF TITANIUM WITH HYDROGEN

NASA-MANNED SPACECRAFT CENTER STRUCTURES AND MECHANICS DIVISION

CONTRACT NO. NAS 9-6565

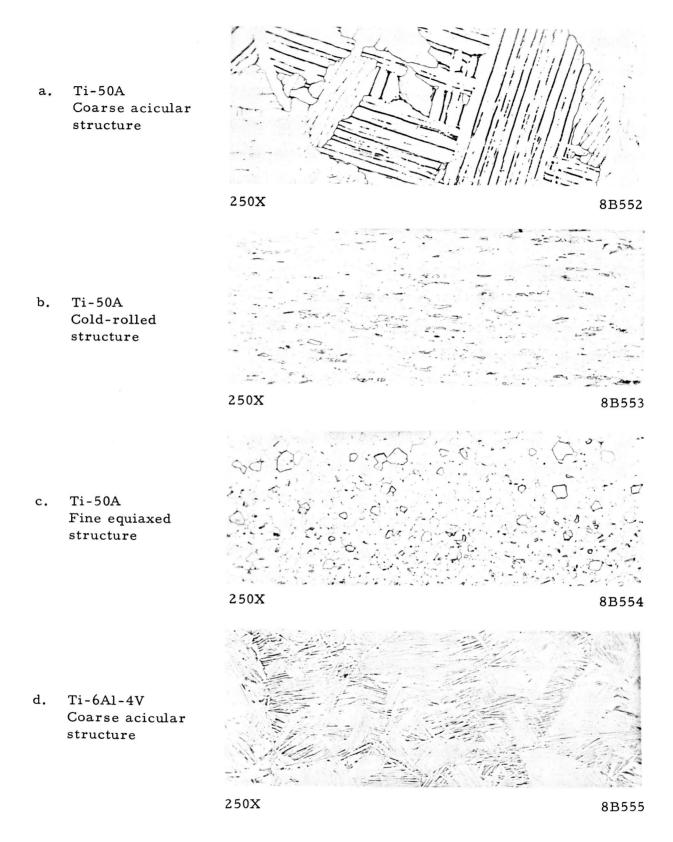
FIGURE 1. MICROSTRUCTURES OF THE FOUR TITANIUM MATERIALS

These treatments provided four different materials for evaluation. The resulting microstructures are shown in Figure 1. Of particular interest are the observations that a significant amount of beta was present in the acicular Ti-50A and that the acicular Ti-6Al-4V developed a considerably finer structure than the acicular Ti-50A.

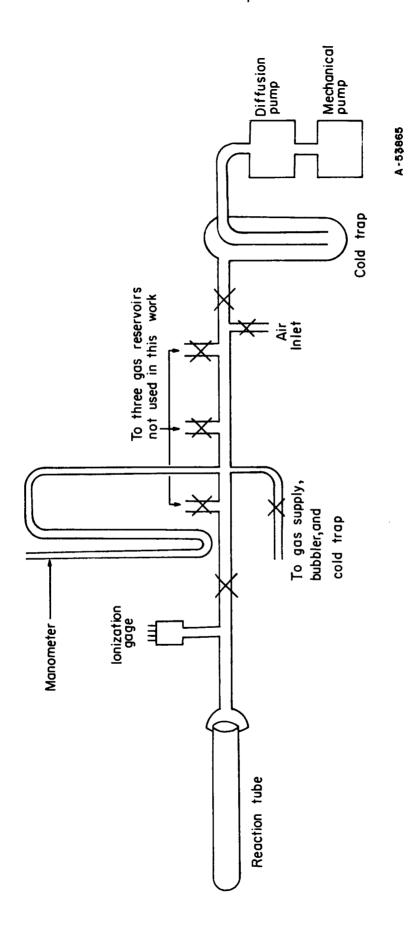
FIGURE 2. DIAGRAM OF GLASS SYSTEM

The holder containing the sample was placed inside the Vycor reaction tube which was immediately sealed to the vacuum system and evacuated. The evacuation was continued with numerous periods of flaming the glassware until the system pressure was

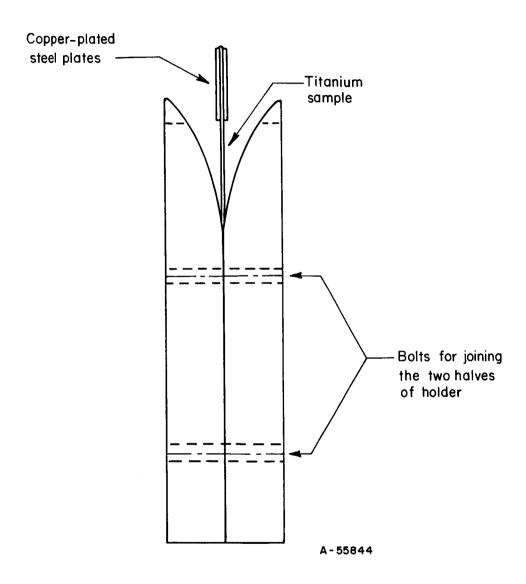
FIGURE 3. FULL-SCALE SKETCH OF SAMPLE HOLDER FOR APPLYING STRESS

The sample holder was constructed of Type 304 stainless steel and consisted of two identical sections. When assembled, with the sample bolted between the sections, the holder was 5 inches in length by 1-1/4 inches square. A drawing of the sample holder is shown in Figure 3. Two sample holders were constructed. One sample holder was machined to a 2.54-inch radius. This provided a maximum strain in 15-mil-thick sheet of 0.3 percent equivalent to a stress of about 50,000 psi assuming elastic binding. The second sample holder was machined to a 0.75-inch radius to provide a maximum fiber strain of 1.0 percent, which would provide appreciable plastic flow on the sample surface.

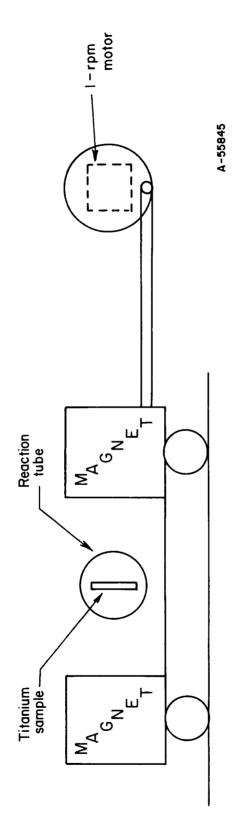
SKETCH OF METHOD FOR APPLYING STRESS TO THE SAMPLE FIGURE 4.

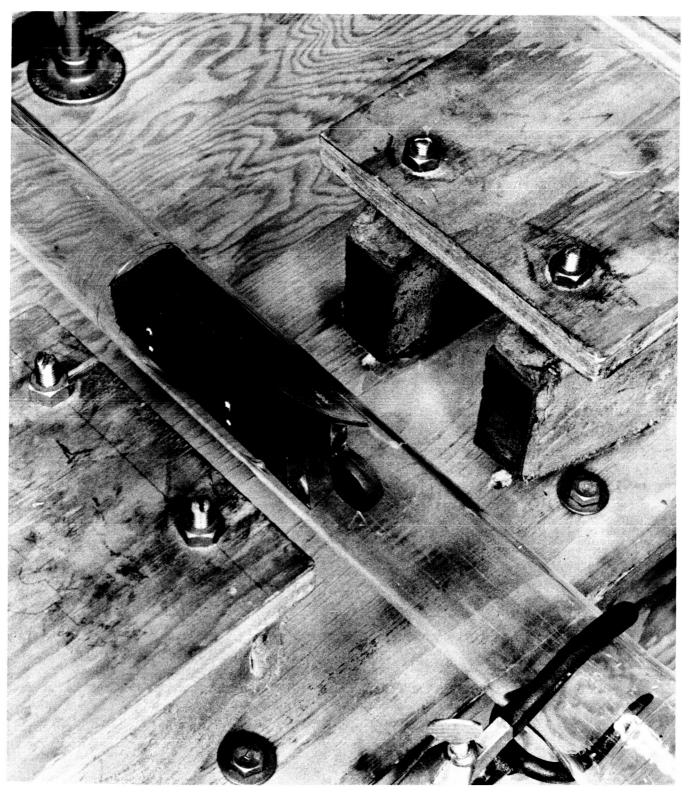
37480

FIGURE 5. METHOD OF PRODUCING STRESS IN TITANIUM SAMPLE IN GLASS SYSTEM

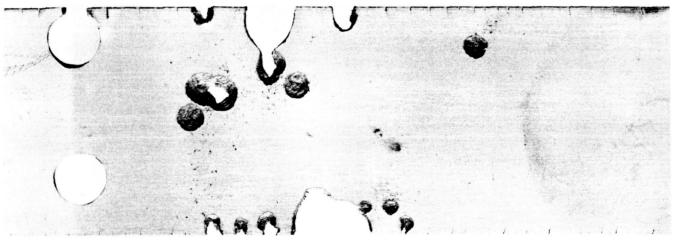
3X 4B106

FIGURE 6. SAMPLE 16-S ACICULAR Ti-6AL-4V SHOWING RESULT OF HYDRIDING UNDER STRESS FOR 138 HOURS AT 80 F

As indicated in Table 3, two experimental runs were made using samples of Ti-6Al-4V at the low strain level at 80 F. One nonvacuum-annealed sample (16-S) reacted extensively as shown in Figure 6, the other did not. A third sample strained 1 percent at 80 F did not react. A Ti-65A, 2-mil foil (90 square inches) was present as a getter in the reaction tube with the sample which reacted. Although the titanium foil appeared to have been effective in helping to initiate a reaction with Sample 16-S, its presence in the Ti-50A runs did not appear to aid in obtaining a hydriding reaction.

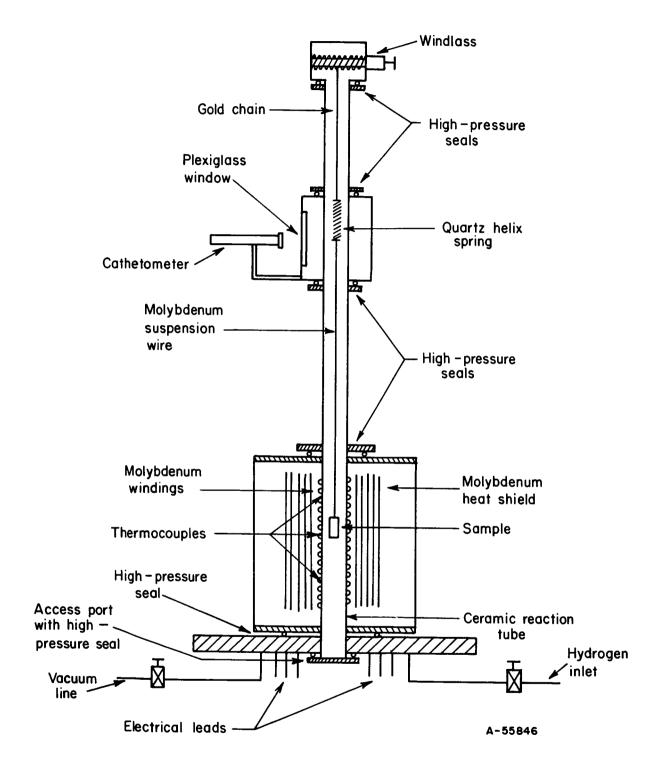
FIGURE 7. DIAGRAM OF QUARTZ-SPRING PRESSURE BALANCE

The balance can be divided into two sections, the upper or suspension section and the lower reaction section. All sections were made of stainless steel and were bolted together with stainless steel flanges using O rings as pressure and vacuum seals.

The reaction section consisted of a resistance-wound (McDanel) impervious ceramic tube of 1-inch ID and 12 inches in length. Three individually wound furnace sections had separate thermocouples and Variac Controls; the center section was monitored by a Foxboro controller. The heating elements were surrounded by a spiral of molybdenum sheet which acted as a radiation shield. All wires and tubing for evacuating and admitting gas were brought in through the bottom stainless steel plate. The outside of the reaction section and the narrow section of stainless steel tube between this section and the cathetometer viewing port were incased in copper tubing for water cooling or warming as desired.

The upper suspension section contained a stainless steel housing for a windlass from which a gold chain was suspended. The quartz spring was suspended from this chain. A 0.004-inch-diameter molybdenum wire was, in turn, suspended from the quartz spring. The sample was fastened to this wire by a small Vycor hook. All samples were 2 inches long, 1/2 inch wide, and 15 mils thick, and unless otherwise stated, were dry abraded with 240-grit silicon carbide paper and rinsed in cp acetone before suspending in the pressure balance system.

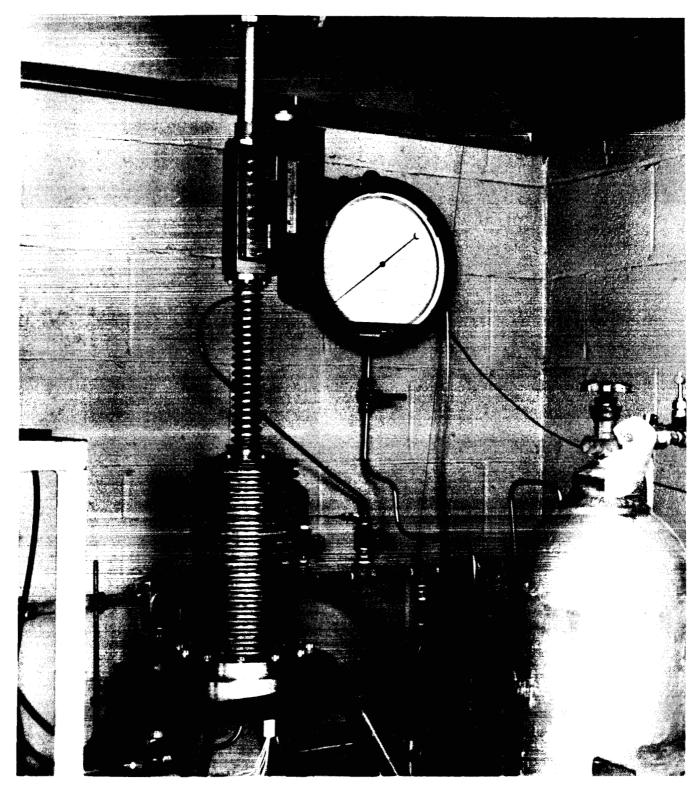
FIGURE 8. THE QUARTZ-SPRING PRESSURE BALANCE SYSTEM

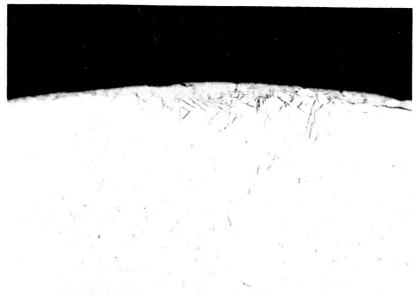
250X 8B556

FIGURE 11. HYDRIDE ON STRESSED AREA OF ACICULAR Ti-50A SAMPLE

Sample reabraded in this stressed area before exposure to 312 psig (22.2 atmospheres) hydrogen for 24 hours at 99 F.

The application of stress to the samples in 1 atmosphere hydrogen pressure proved to be ineffective in initiating a hydriding reaction. To examine the effect of stress at a hydrogen pressure of 312 psig (22.3 atmospheres) hydrogen, three experimental runs were made as described in the Experimental Methods Section and shown in Table 9. No evidence of hydriding was found on any sample which had not been abraded prior to stressing and hydrogen exposure. The samples which had been abraded prior to stressing and hydrogen exposure did not show a heavier concentration of hydride in the strained area. Acicular Ti-50A again showed the greatest hydride reaction with a thin discontinuous layer over the entire surface, while the cold-rolled and equiaxed material showed hydride in isolated spots. No hydride was found microscopically on the acicular Ti-6Al-4V sample; however, vacuum fusion analysis showed 92 ppm hydrogen, a slight increase over the base analysis of 70 ppm. The Ti-50A samples which had been reabraded only in the stressed area just before sealing into the reaction system showed a thin continuous hydride layer in that area for all three grain structures. The hydride layer formed on the acicular Ti-50A is shown in Figure 11. The remainder of the surface of the acicular material contained a thin discontinuous hydride layer while the coldrolled and equiaxed material contained isolated spots of hydride outside the strained area.

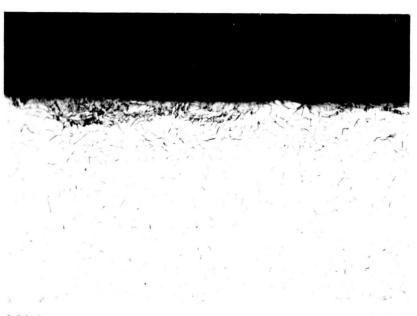
250X 83557

# FIGURE 12. HYDRIDE ON EQUIAXED Ti-50A SAMPLE

Same run as above sample but not stressed or reabraded in this area. Believed to have been scratched by dies during bending. Note similarity to Figures 15 and 16.

Several isolated areas of hydride were found on the inner surface of the stressed and reabraded equiaxed material at some distance from the strained area. These hydrided areas differed considerably from those found on all Ti-50A samples previously exposed to hydrogen and on other areas of the same sample. This hydride, rather than being all concentrated near the surface, appeared to radiate inward in small needlelike particles from the surface hydrided areas as shown in Figure 12. Apparently, the surface was rubbed or slightly scratched in this area by the steel die used in bending the sample. This probably initiated the reaction, which perhaps caused local heating in spots, resulting in an inward diffusion of the hydride from the surface hydrided areas.

been scratched by steel during stressing (Figure 12). A fourth piece of tubing was rubbed with the same steel while both were heated in air at 400 F. No increase in hydriding above that found on the as-received material occurred. This was probably due to the increase in oxidation of the surface caused by heating in air.

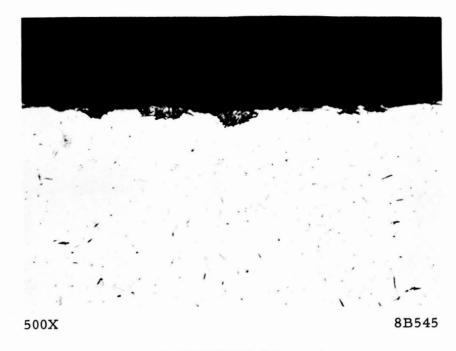
FIGURE 13. HYDRIDE AREAS ON INSIDE OF TITANIUM TUBING SAMPLE 27

Reacted in the "as-received" condition with 315 psig (2.24 atmospheres) hydrogen for 24 hours at 99 F.

Data from the four experimental runs made with the Beech Aircraft titanium tubing are presented in the Appendix, Table A-2, Samples 27 through 30. Figure 13 shows the hydride formed on the inner wall only, of the tubing exposed to 315 psig (22.4 atmospheres) of hydrogen for 24 hours at 99 F. This tubing was exposed in the as-received condition, with no pretreatment except degreasing in cp acetone. The tubing after etching and exposure to hydrogen is shown in Figure 14. No reaction with hydrogen occurred. Figures 15 and 16 show the hydride formed on the inside surface of the titanium tubing after rubbing this surface with a piece of high-carbon, high-chromium steel to simulate what is believed to take place during fabrication of the tubing. Note the similarity of this hydride to that found on the equiaxed material which was believed to have

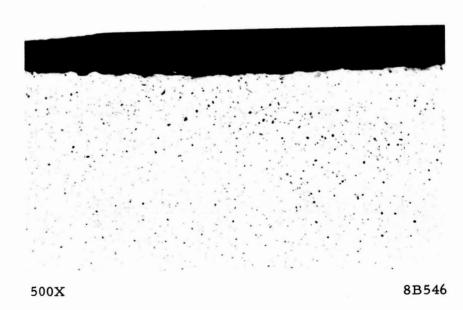
FIGURE 14. SURFACE OF INSIDE OF TITANIUM TUBING WHICH WAS ETCHED AND DID NOT HYDRIDE, SAMPLE 28

Tube etched in HNO<sub>3</sub>-HF-H<sub>2</sub>O solution, then exposed to 311 psig (22.2 atmospheres) hydrogen for 24 hours at 99 F.

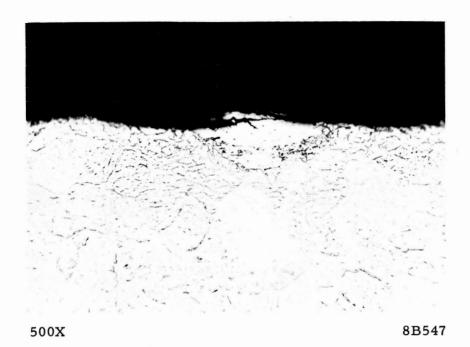
FIGURE 15. HYDRIDED AREA ON INSIDE OF TITANIUM TUBING SAMPLE 29

Rubbed with steel before reacting with 313 psig (22.3 atmospheres) hydrogen at 99 F for 24 hours. Note radiating hydride particles. Large particles 1.4 mils thick. Radiating particles extend to over 1/3 of tube-wall thickness.

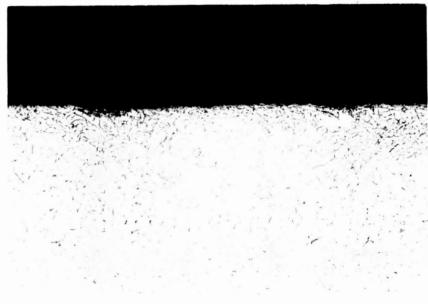
250X 8B548

FIGURE 16. A REPRESENTATIVE AREA OF HYDRIDE FORMED ON INSIDE OF TITANIUM TUBING SAMPLE 29
